JSC-10613

NASA TECHNICAL MEMORANDUM

FULL-SCALE AIRCRAFT CABIN FLAMMABILITY TESTS
OF IMPROVED FIRE-RESISTANT MATERIALS —
TEST SERIES II

6. Performing Organization Code JSC-10613	
7. Author(s) Robert N. Stuckey, Richard W. Bricker, Jerome F. Kuminecz, and Daniel E. Supkis				8. Performing Organization Report No.

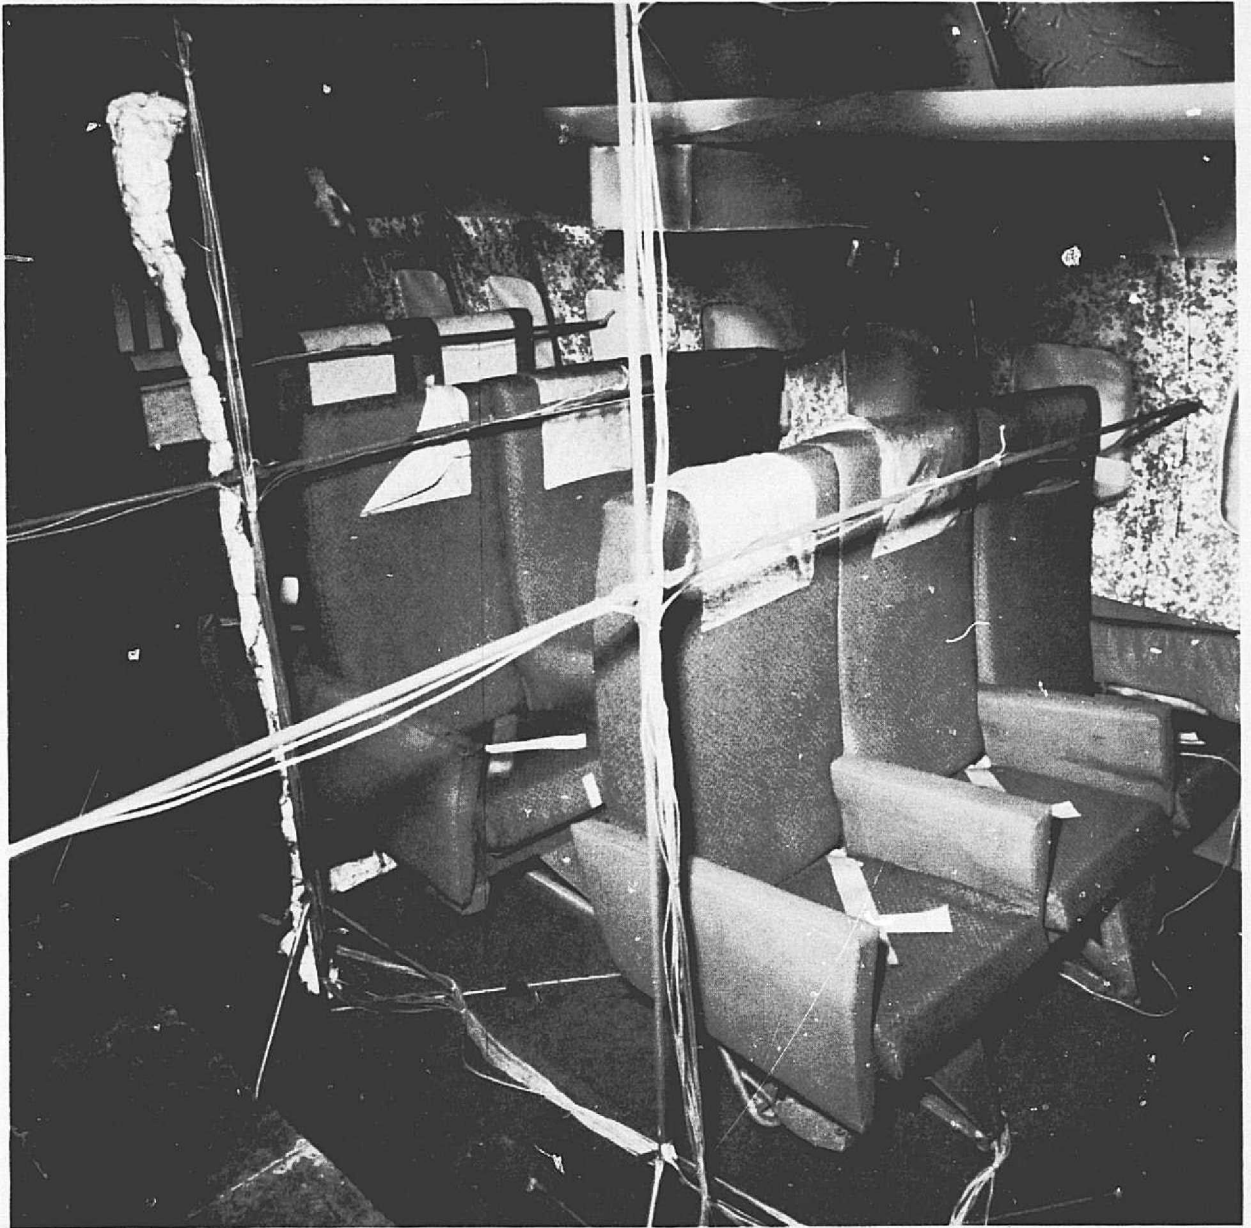
1. Seats: The seat above the ignition source was partly consumed by the fire, and some of the metal structure melted. Approximately 50 percent of the bottom seat-cushion upholstery was consumed, and the remaining material was scorched. Approximately 90 percent of the fire-retardant foam padding of the bottom seat-cushion was consumed. The Nomex seatbelt was completely charred. The front of the seat-back upholstery was 30 percent consumed, 30 percent charred, and 10 percent scorched; the opposite side was about 15 percent consumed, 5 percent charred, and 10 percent scorched. The foam padding of the seat back was approximately 50 percent consumed. The armrest covering was about 50 percent consumed, and the remaining material was charred or scorched. The headrest napkin was scorched but did not burn. Except for slight scorching of the center seat adjacent to the damaged seat, the other seats were not damaged.

2. Sidewall: A triangular area of the lower sidewall adjacent to the fuel pan, covering about 0.13 square meter (200 square inches), was completely charred. The sidewall above this area was scorched and blackened up to the hatrack (fig. 12).

Figure 12.- Fire damage for test 4 using new materials B,
front view.

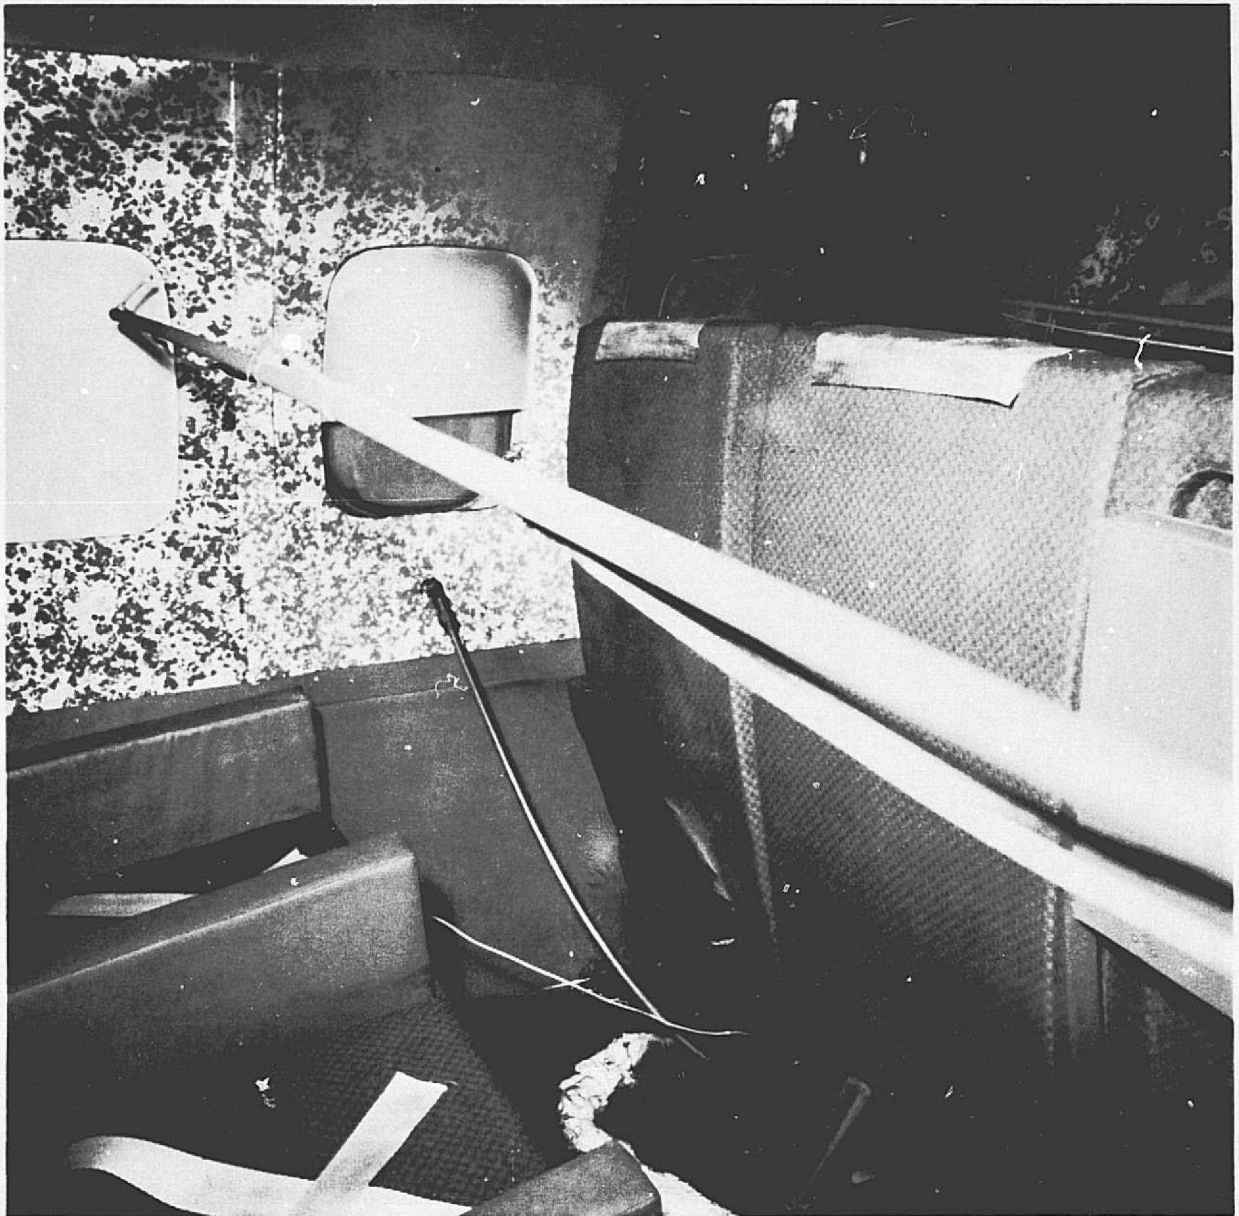
Figure 13.- Sidewall and back of seat fire damage for test 4,
using new materials B.

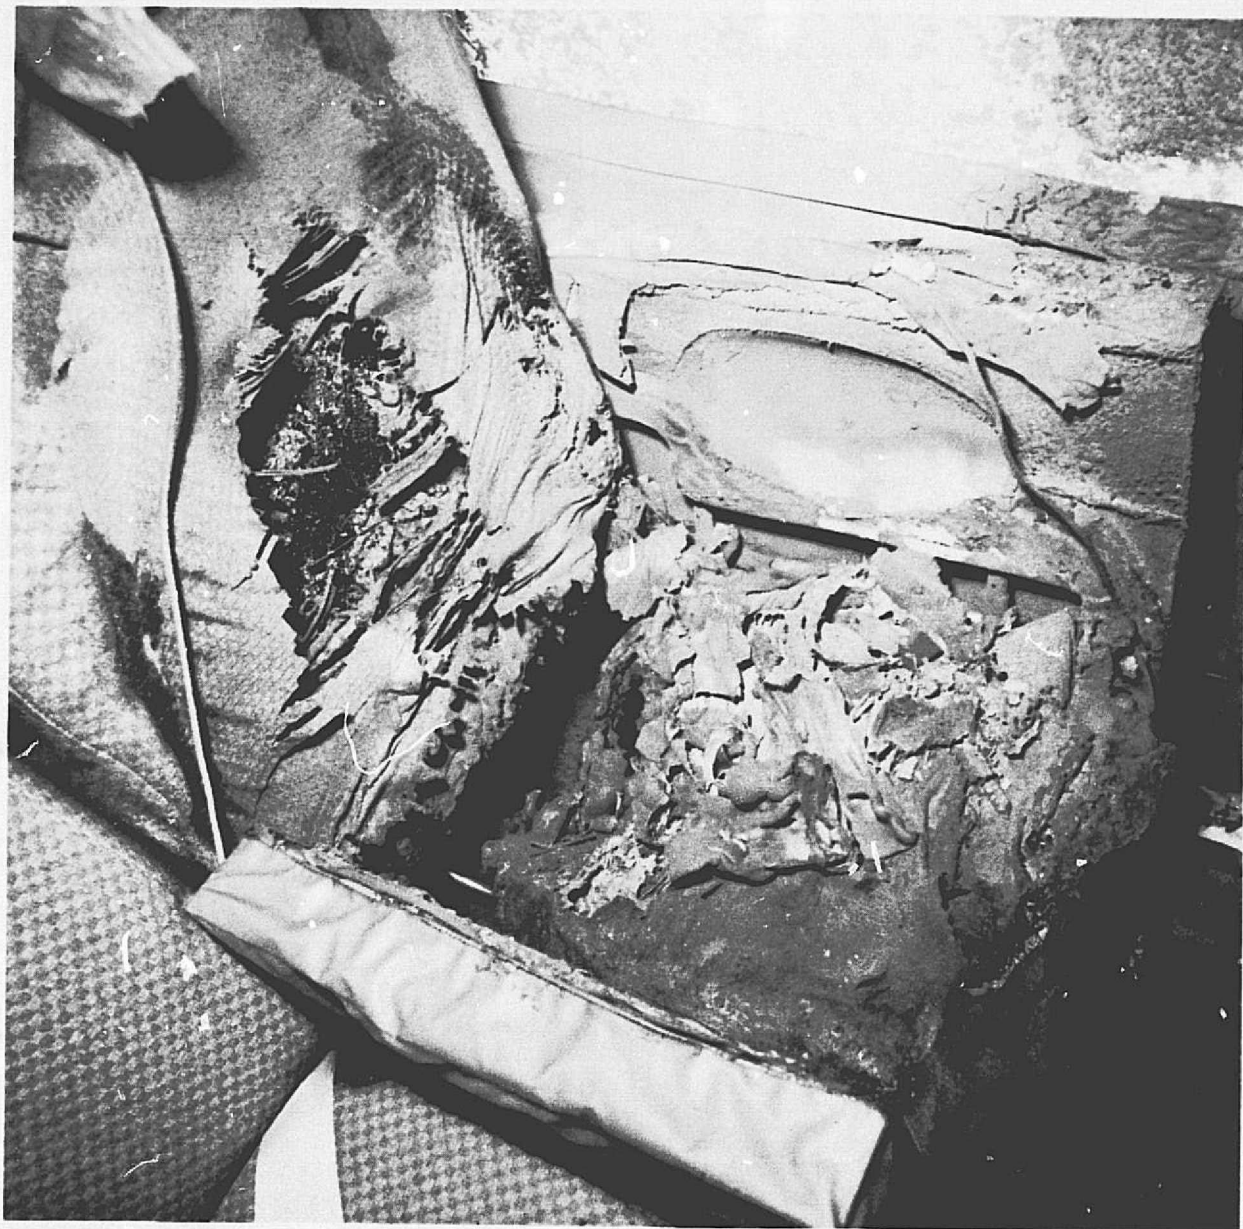
Figure 14.- Seat fire damage for test 4 using new materials B.

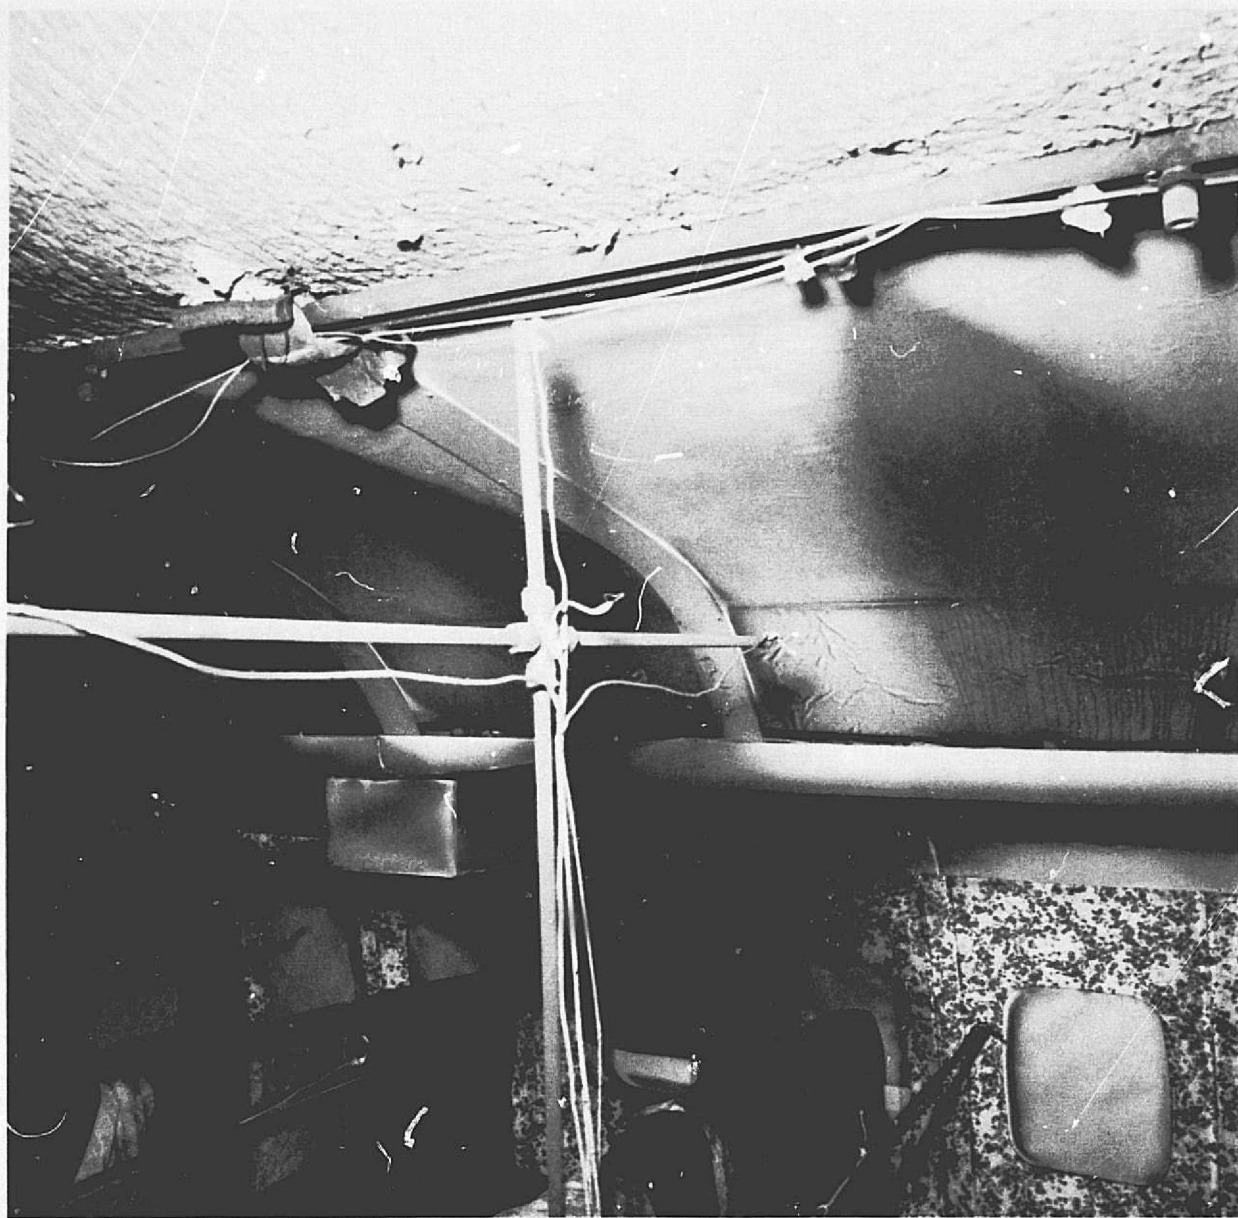
4. Ceiling panels: The ceiling panels were slightly scorched and blistered by the heat.

Figure 15.- Ceiling fire damage for test 4 using new materials B.

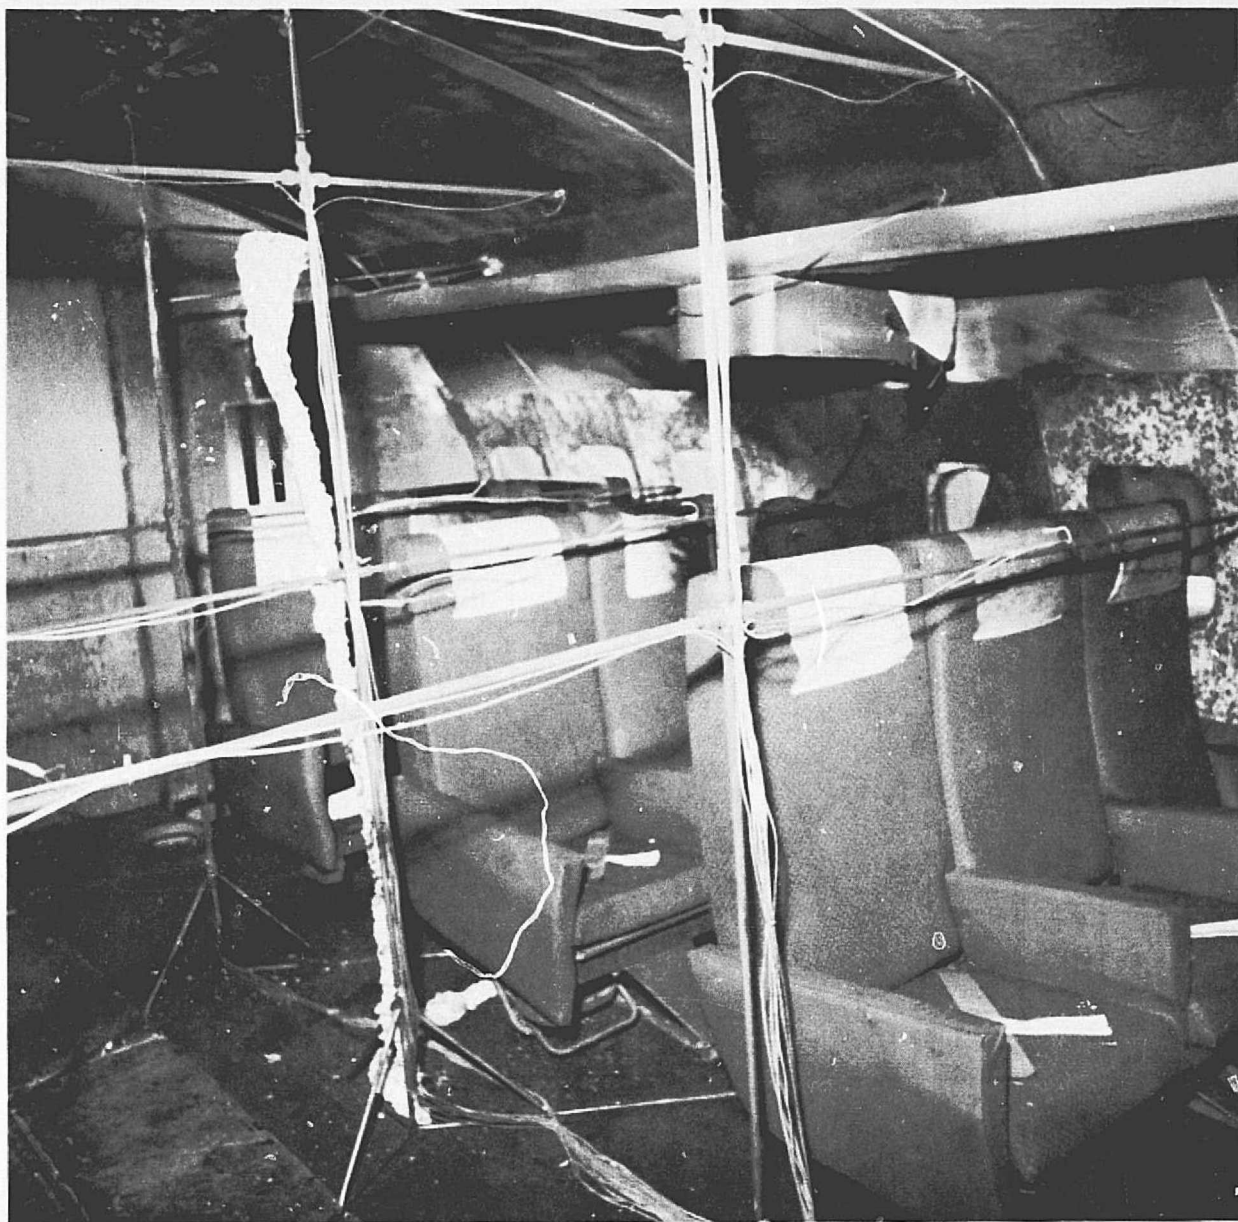
Figures 25 to 29 clearly show that the fire did not propagate, although the seat above the fuel pan and the adjacent sidewall sustained major damage. The only damage to the third row of seats was the scorched headrest napkins; the rest of the damage was sustained in test 4. (Between tests 4 and 5, the middle and back rows of seats were exchanged to provide an undamaged row for test 5.) Figure 5, a pretest photograph for test 5, shows some of the damage resulting from test 4. Although the initial fire was larger than those in previous tests with new materials, the temperature data indicated that, after 240 seconds, the fire was decreasing in size. The test was therefore continued until 900 seconds elapsed time, when the fire was extinguished.

Figure 25.- Fire damage for test 5 using new materials B, front view.

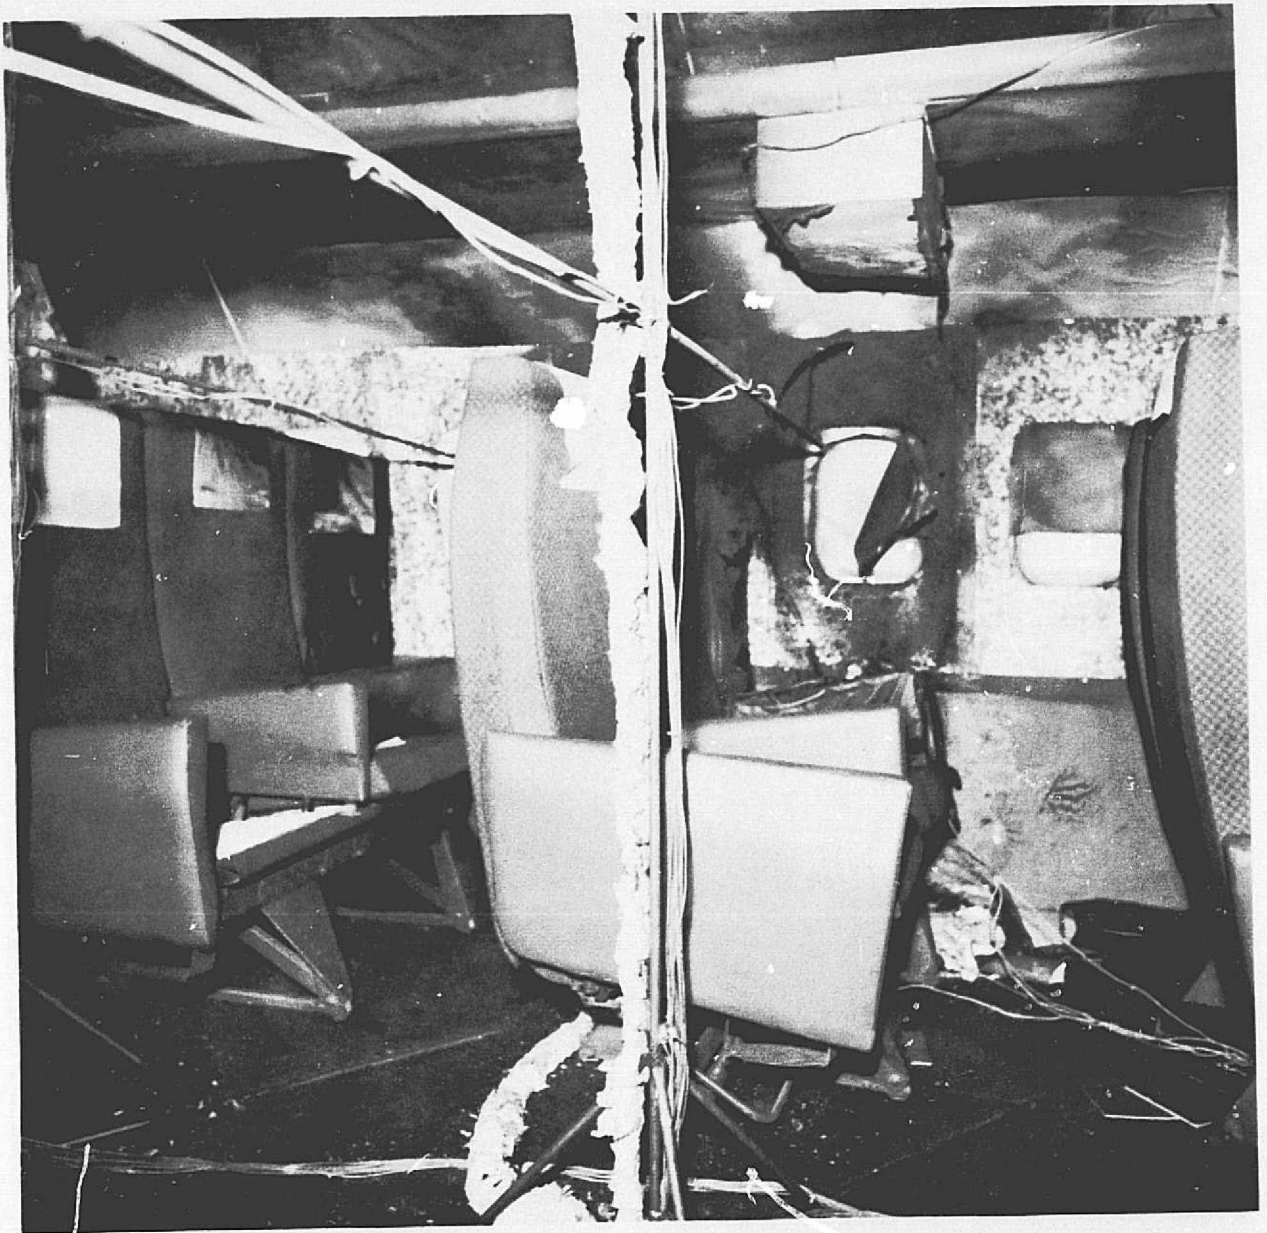
2. Sidewall: A 0.6-meter (2 foot) wide section of the sidewall covering (Kynar decorative laminate) adjacent to the fuel pan was charred from the floor to the hatrack. The sidewall extending outward from each side of the charred area was scorched and blistered; because of the direction of airflow, greatest damage was toward the rear of the test section (figs. 26 and 27).

Figure 26.- Fire damage for test 5 using new materials B,
side view.

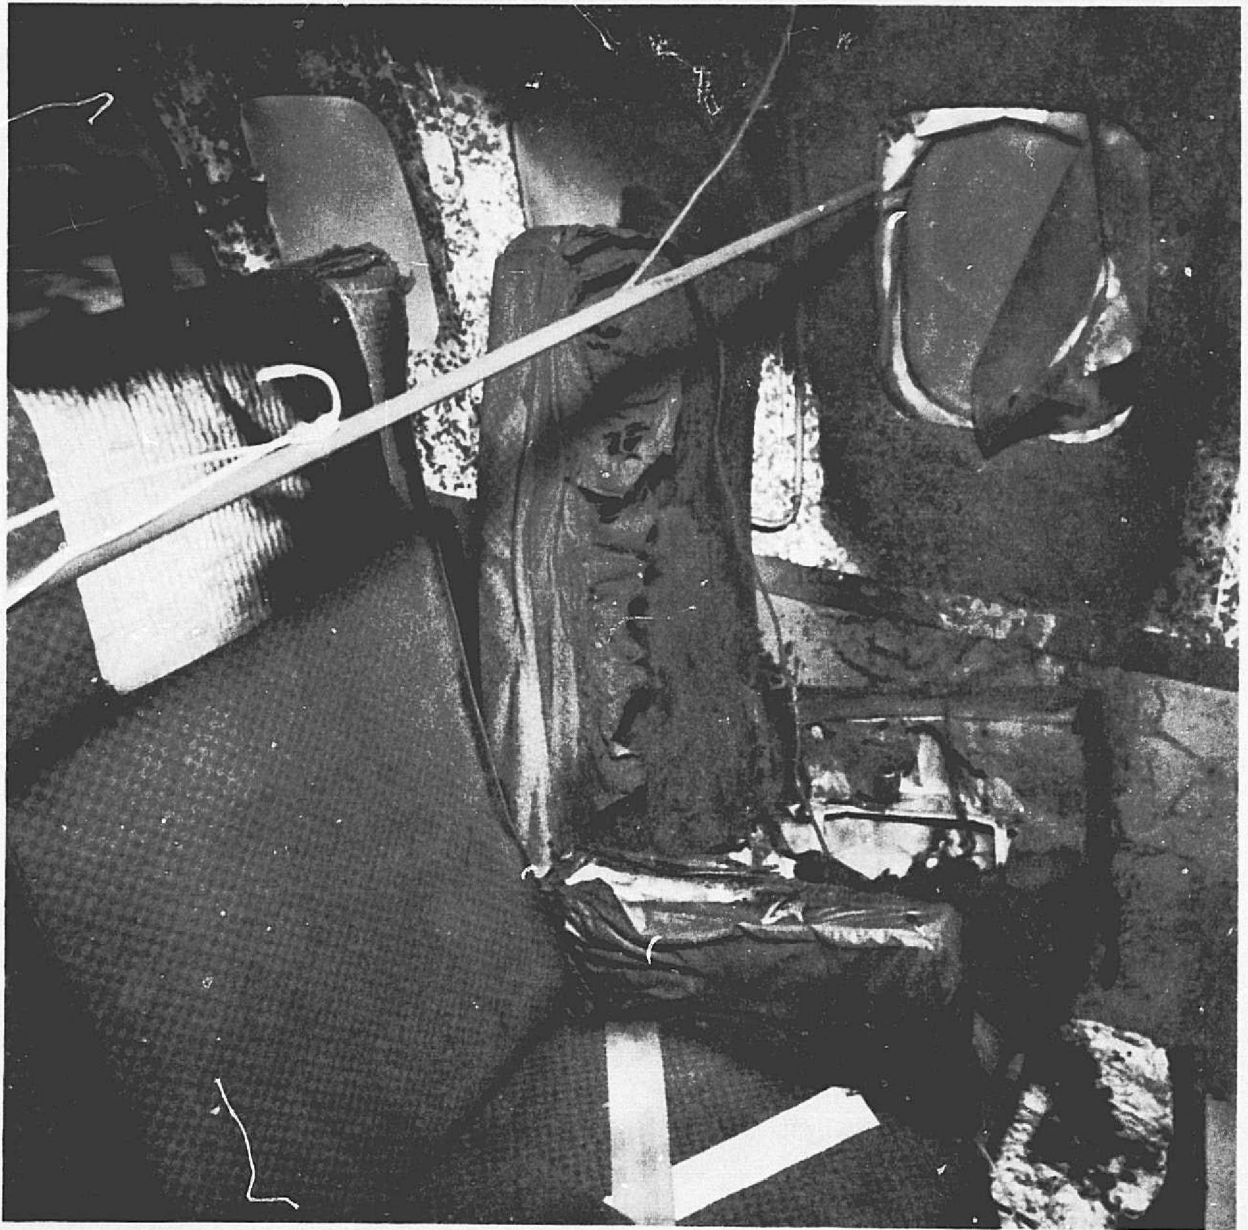
1. Seats: The seat above the ignition source was almost completely destroyed by the fire. Damage included

much of the metal structure, which melted and caused the remaining portion of the seat to fall against the cabin wall. About 95 percent of the bottom seat-cushion upholstery was charred or consumed, and all the fire-retardant foam padding was consumed. The Nomex seatbelt was completely charred. The front of the seat-back upholstery was 90 percent consumed and 10 percent charred, the back side was about 20 percent consumed, 20 percent charred, and 20 percent scorched. The seat-back foam padding was completely consumed. About 50 percent of the armrest covering was consumed, and the remaining material was charred or scorched. The headrest napkin was completely scorched. The upholstery of the seat adjacent to the seat over the ignition fuel pan was slightly charred and scorched. The headrest napkin of the adjacent seat was about 50 percent scorched. The back of the seat in front of the ignition source was about 75 percent scorched. All the remaining headrest napkins were scorched to a maximum of approximately 40 percent.

Figure 27.- Seat and sidewall fire damage for test 5 using new materials B.

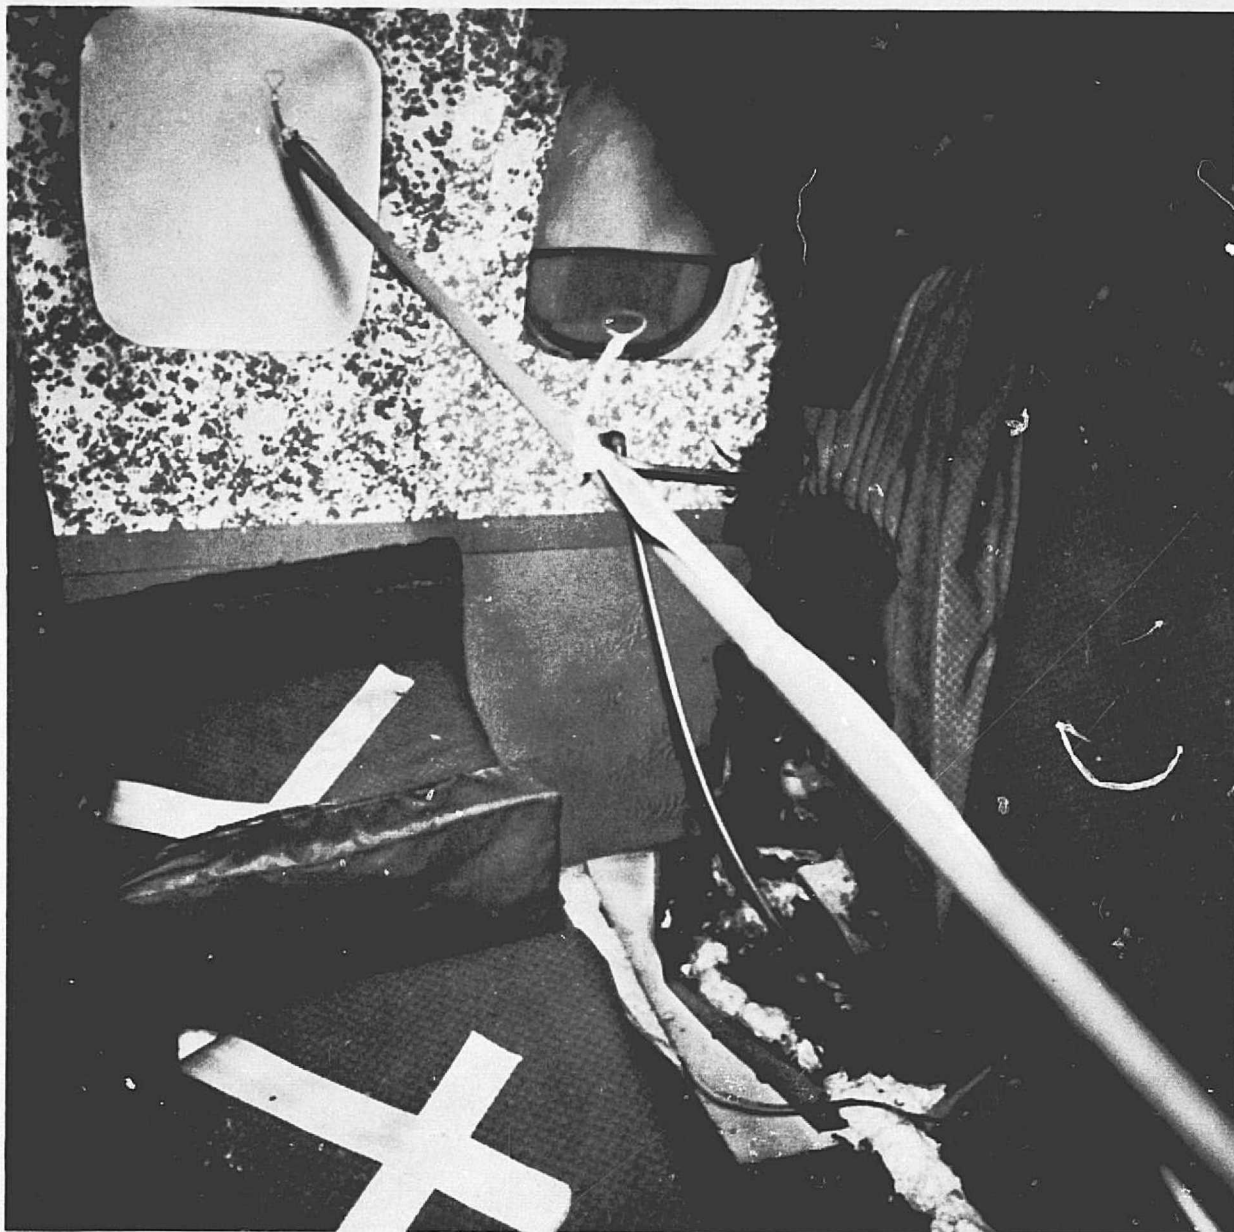
Figure 28.- Back of seat fire damage for test 5 using new materials B.

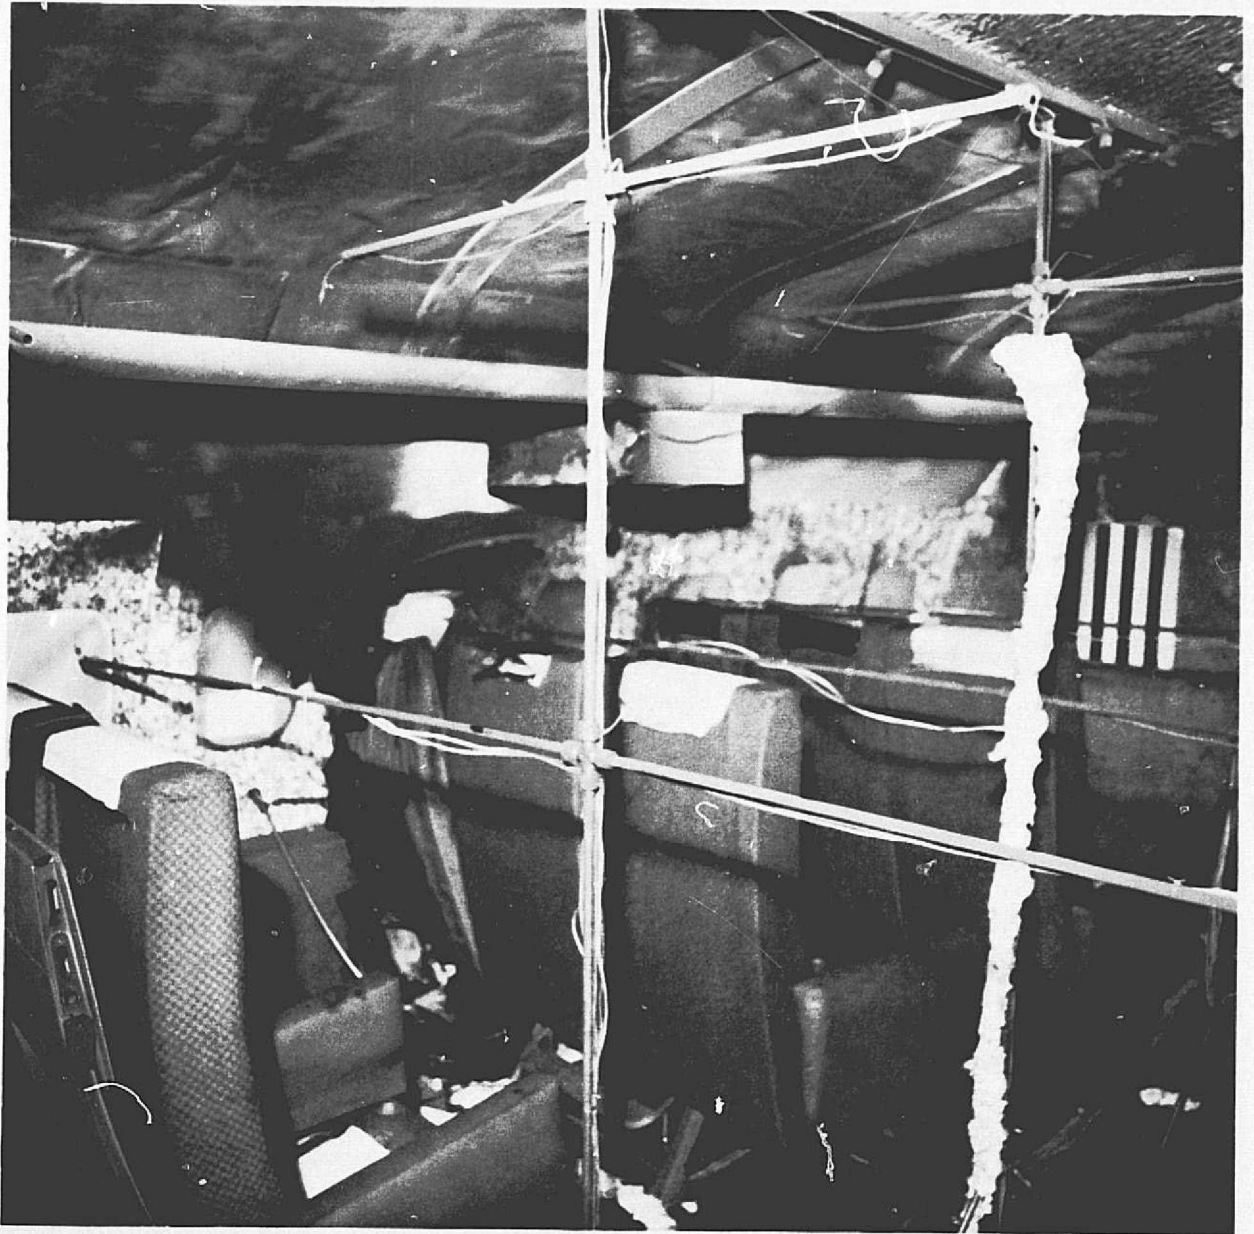
4. Ceiling panels: All the ceiling panels were moderately scorched and blistered. Again, the damage to the rear half of the panels was more severe than that to the front half (fig. 29).

Figure 29.- Fire damage for test 5 using new materials B, back view.
